March 24, 2015

Site Visit Report:

Assessment of Brick Porch Foundations

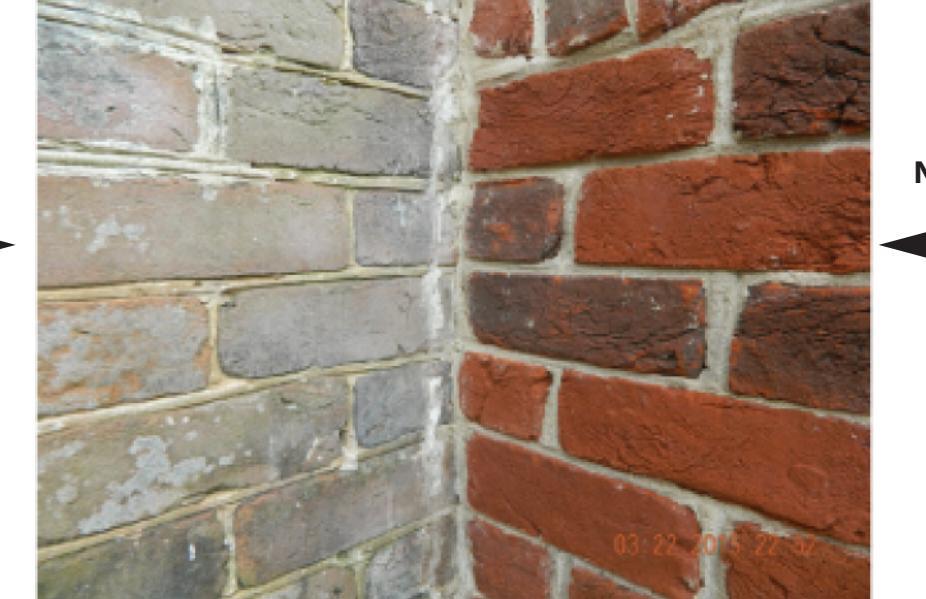
The first thing that struck us was the type of brick used. The brick is not a close match to that of which the home is built. The color stands out and the texture of the exposed surfaces does not resemble that of the home. There are pits and voids in the brick which are out of character to the original. One of the additional issues that the pits and voids cause is that when the mortar is struck after the brick is set, mortar occupies these spaces and the joints appear to be larger than the original. This is most evident at the corners of the new brick. The new brick corners are not as square as the original corners.

New Brick

Original Brick

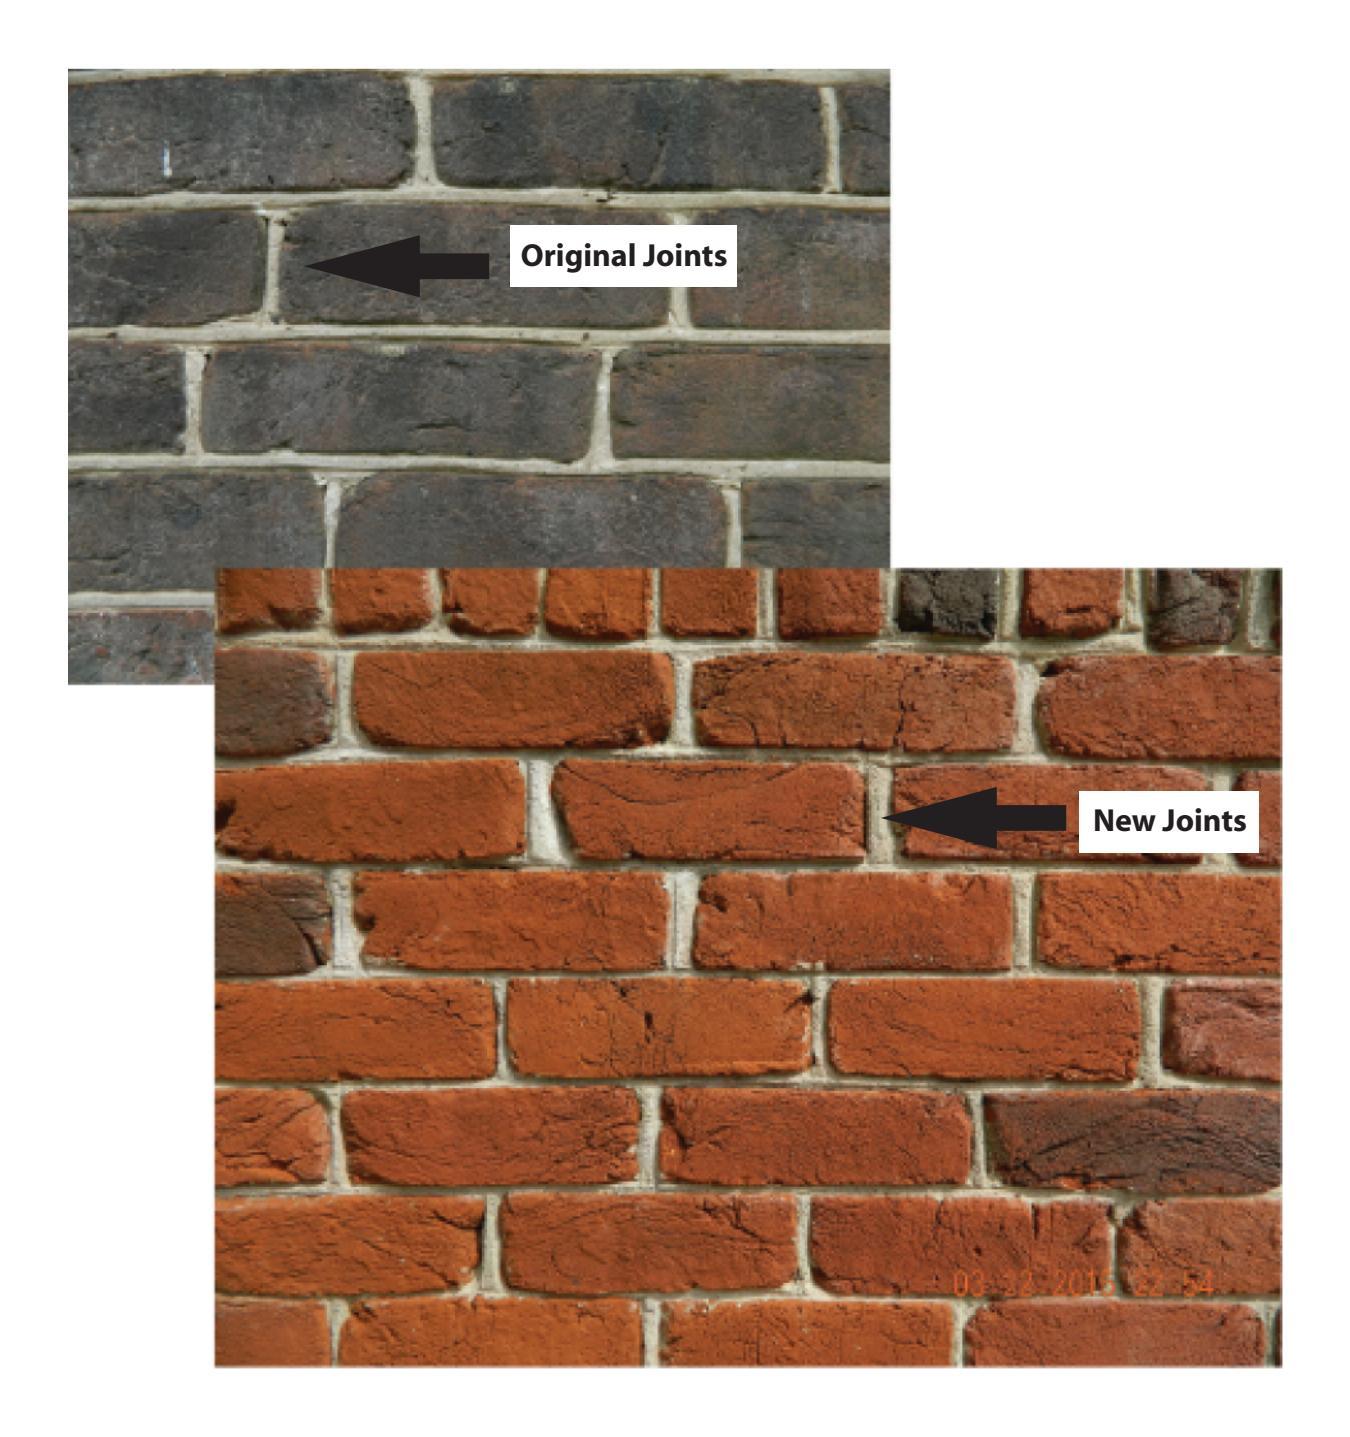
The tooling of the brick joints is of poor quality. An effort had been made to try to replicate that of the original house but it does not match. It appears to have been done by someone without experience matching and replicating surrounding work. It is recessed too far back into the joint, it has not been struck cleanly, and appears in many places to have a washed out appearance. Proper tooling takes experience and patience. It is necessary to spend time learning and practicing these strikes prior to actually doing them to finished work.

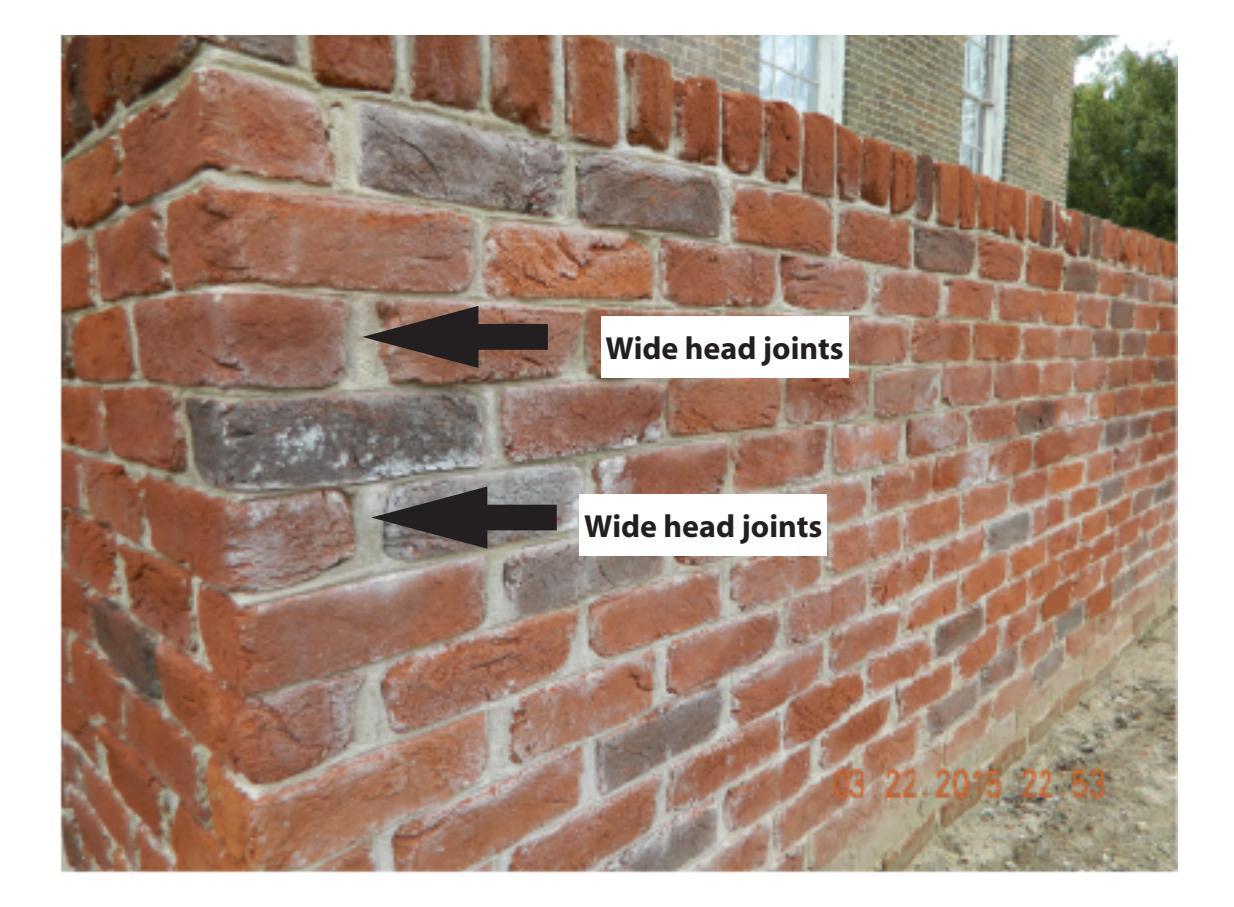
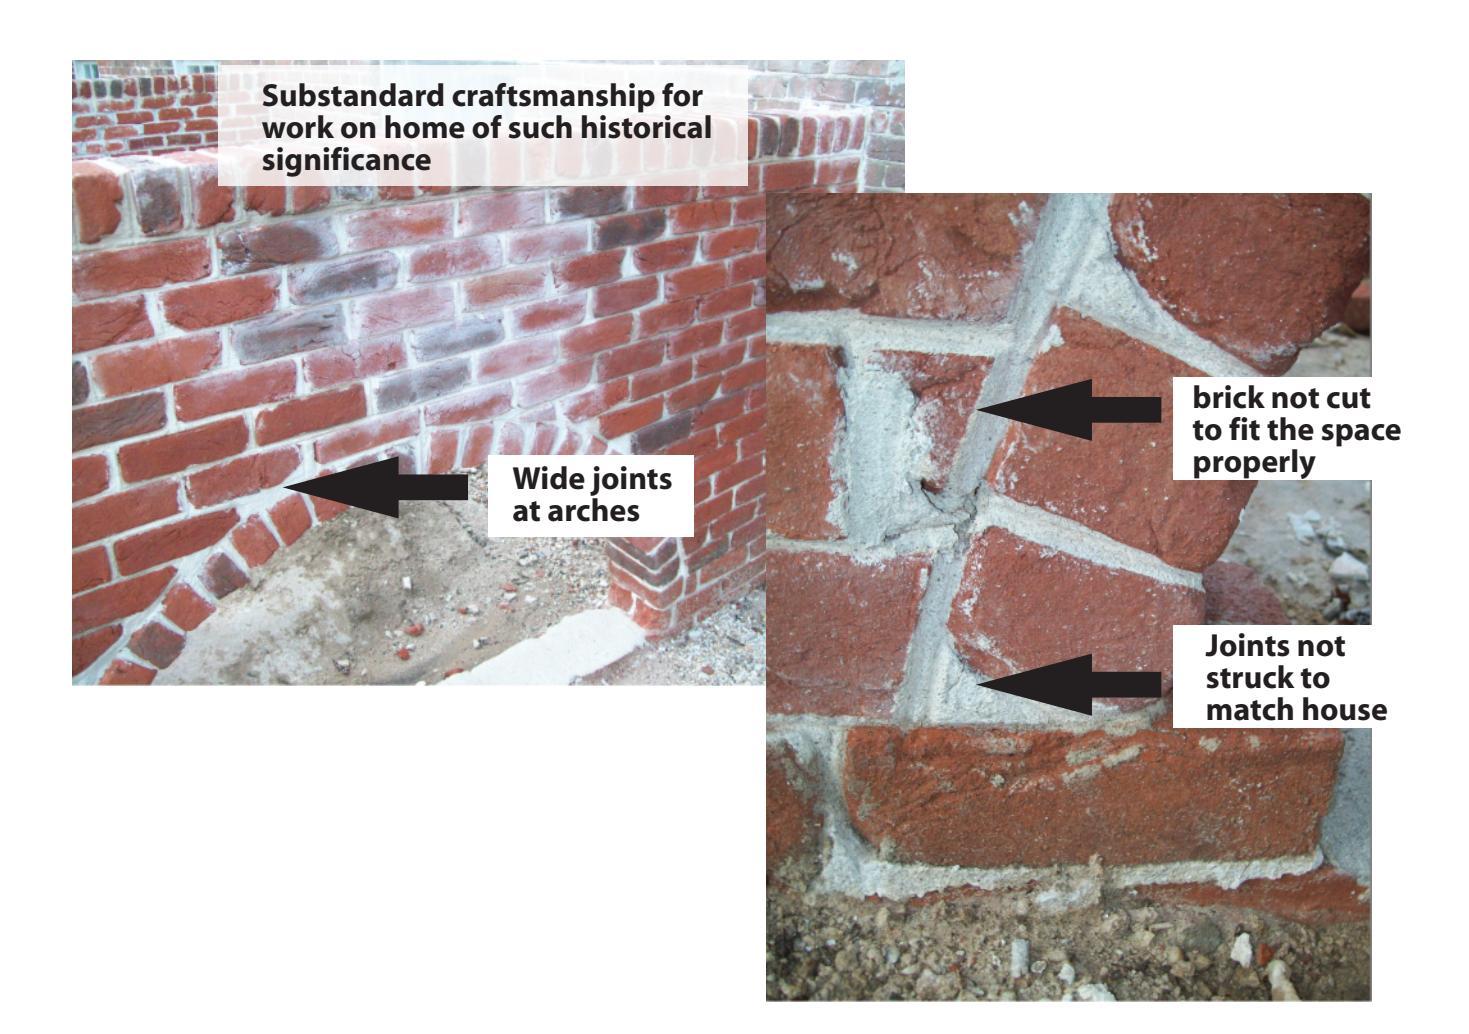
The joints of the new brick work are wider than that of the original. This is most evident at the head joints, the ends of the bricks where they meet horizontally. The original bricks were pressed tightly together when they were set. This was done both for aesthetics as well as minimizing water infiltration into the wall through the joints. The joints of the new work are totally out of character from the original brick work on the house.

The primary visual features of the foundations are their arches. These photos show the lack of attention to detail in the width of the joint, the strike of the joint, and an apparent lack of effort to properly cut the brick pieces that fit between the courses of brick and the brick comprising the arches. These details are completely out of character and unacceptable in historic masonry replication.

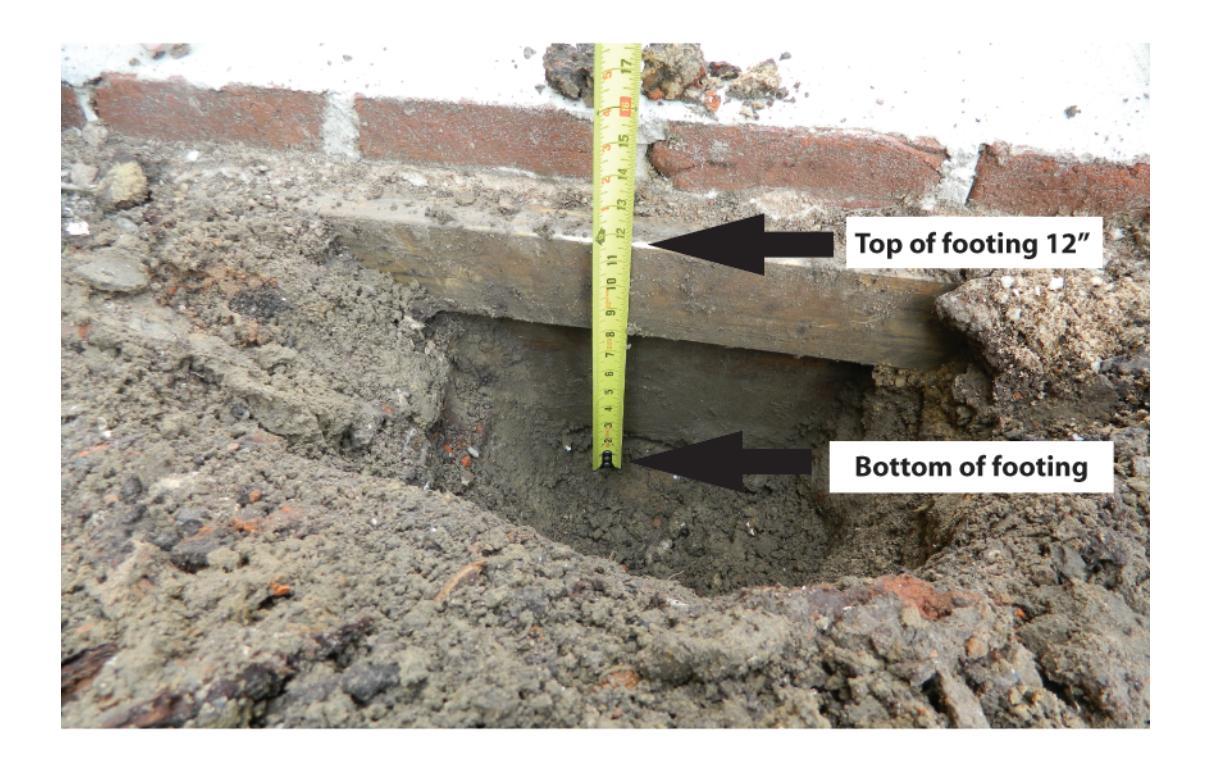
From a structural standpoint the new brick porch foundations are not sound. The building code for Northumberland County specifies that the footings for the porch should extend a minimum of 18 inches below grade. We have confirmed this requirement with Bill Knight of the Northumberland County Building Department. The footings of the new porch foundations extend only 12 inches below grade. Further, their outside dimension does not extend beyond the brick work.

Per our conversation with Doug Harnsberger, AIA of Legacy Architecture, we agree with his assessment that the footings should have been extended 6 inches past each side of the brick foundation for a total footing width of 20 inches. We cannot verify if any rebar was included / installed in the current footings. Per Mr. Harnsberger, any new footing that is installed should have two sections of epoxy coated rebar run continuously through the length of the footing.

Considering a two story porch will be supported by the footings and foundation, the original design and execution is flawed, does not meet code, and could result in a failure of the entire porch system.

This structural issue is enough for us to recommend that the two brick porch foundations be torn down and rebuilt on footings that meet code requirements in a manner that is sympathetic to the original fabric of the home. Greater effort should be given to the selection of brick to be used in the rebuilding of the porches and only qualified craftsmen employed in their rebuilding to ensure that the work meets the high standards of the home.
